## Re-doing the doors on *Annie* 26-064

A project description by Ruth Jansson & Bette Conner, 1/10/04

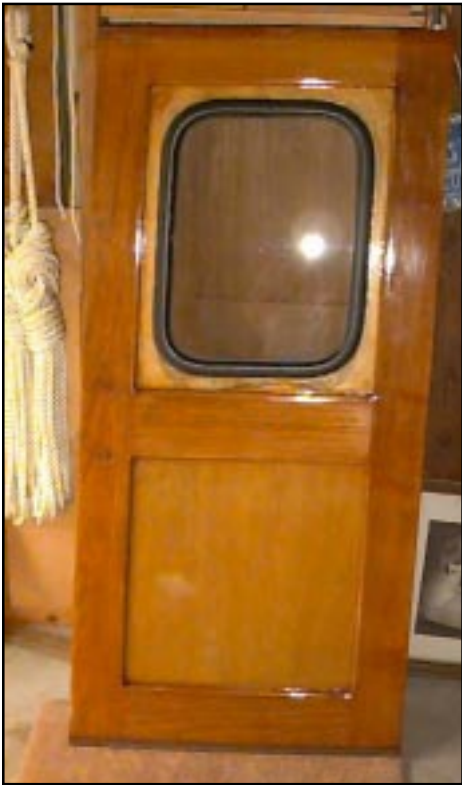
By way of introduction, *Annie* is a 1982 Nordic Tug. We purchased her in 1994 and enjoyed her for 6 wonderful years. During that time water damage on the doors became more and more evident. During the summer of 1997, we made a temporary door and brought the doors home, one at a time, to re-make them. We took some pictures now and then during the process.

*Exterior of starboard door*

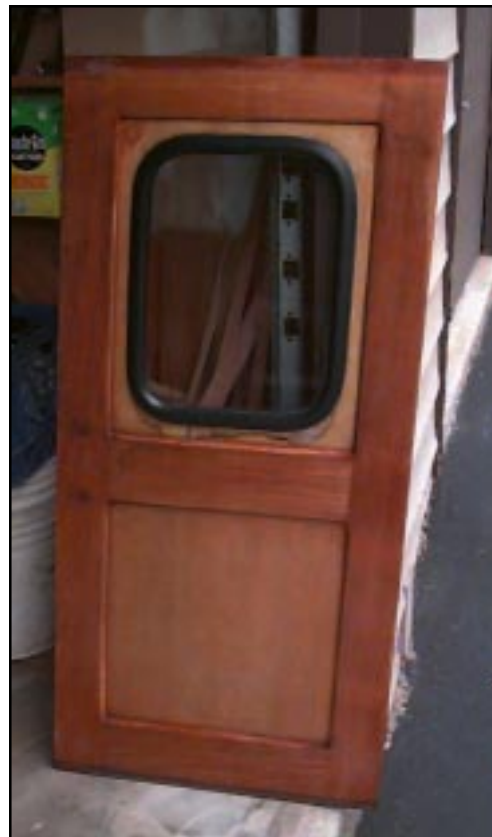
*Interior of starboard door*

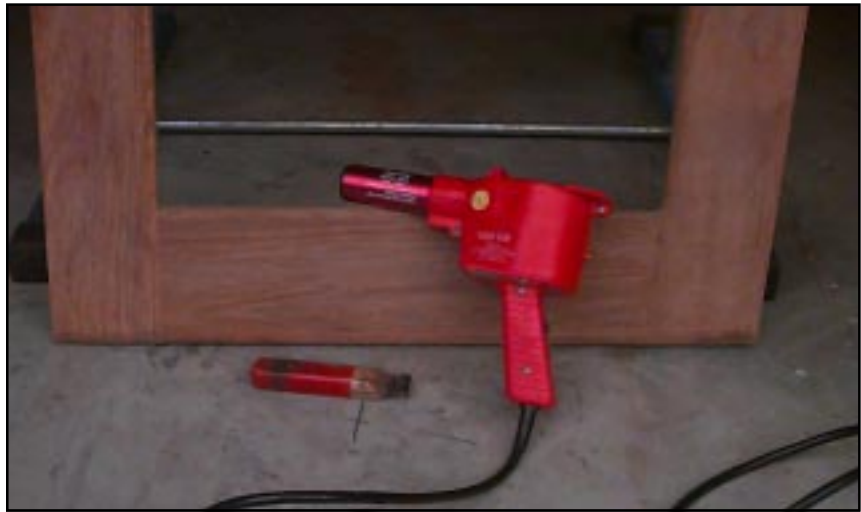
*Heat gun recommended by Rebecca Wittman,*

Next we removed the varnish from the exterior side. When we first got *Annie*, we had picked up a copy of Rebecca J. Wittman's book *Brightwork: The Art of Finishing Wood* and considered it our bible for varnishing. She recommended a particular heat gun called the Easy Gun\* which we immediately purchased, and we used it to re-do all the varnish on the boat. It's a great heat gun—and made the job of stripping the doors quite easy.

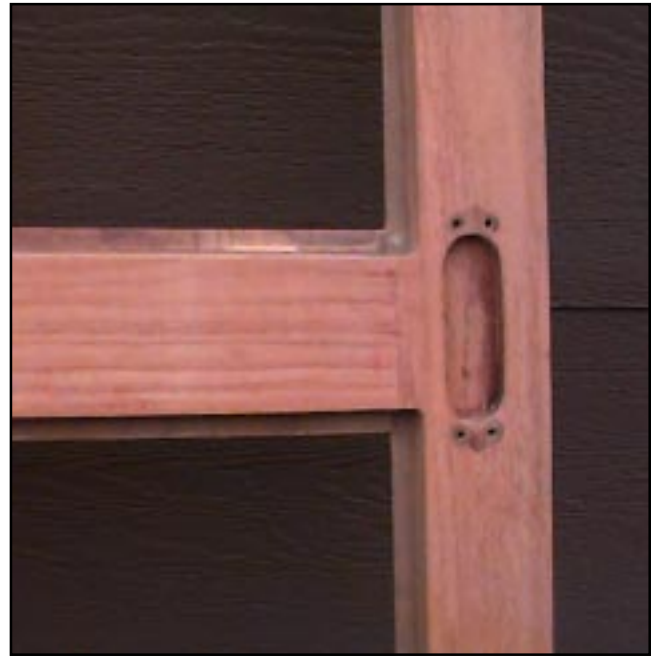
*Inside of door with back routed out.*

I don't remember if I had to increase the routed edges on the inside, but I think I did so that the glass and the lower panel would have more to rest on and consequently sit more securely.

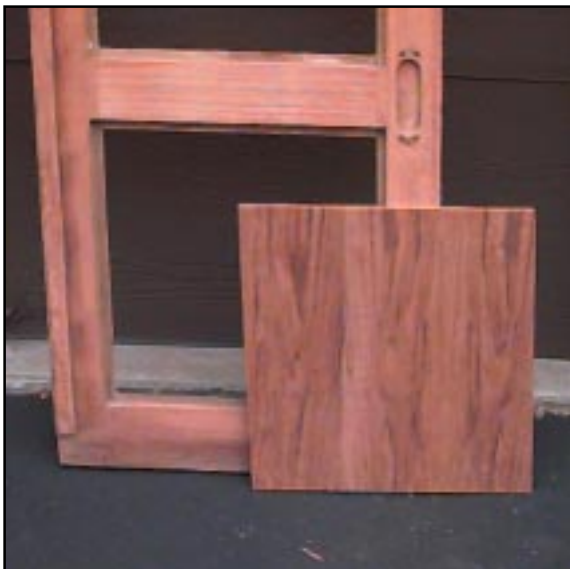
*Lower door panel*

- When selecting/cutting/installing the panel, remember to make the grain run vertically.
- Do not glue the panels; they need to be able to move.
- Predrill holes in the molding before nailing it in to the sides; otherwise the molding pieces will split.

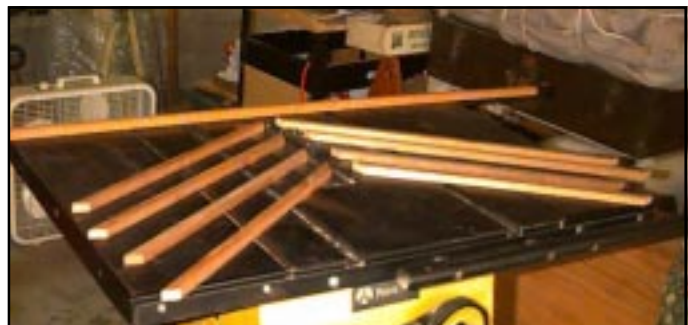
*Molding cut from teak wood*

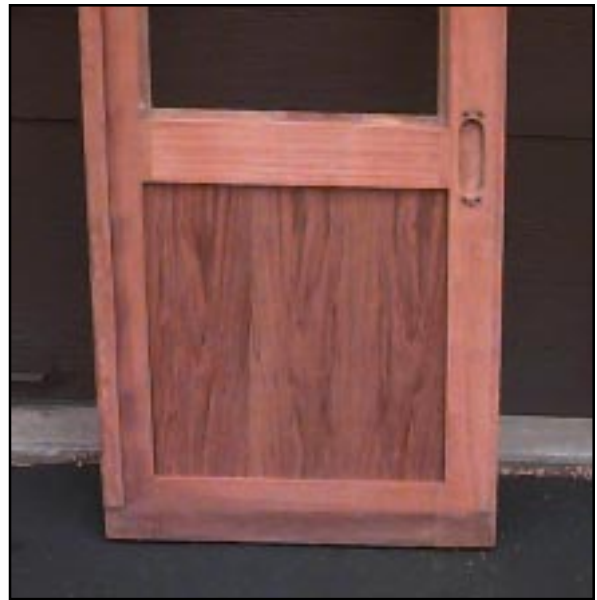
*Panel installed, but before molding is attached*

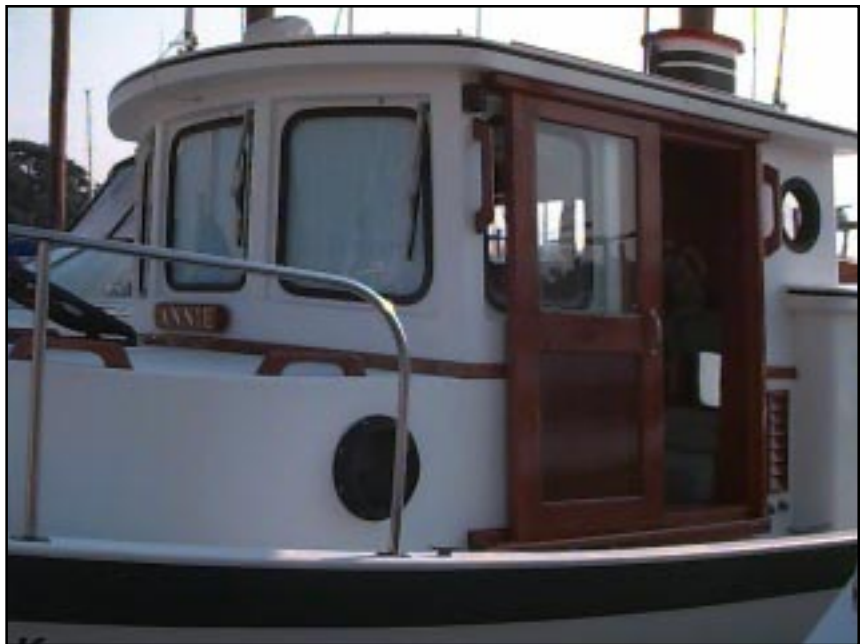
*Annie sporting her new door*

Once the doors were completely assembled and finished, we sanded and sanded until the wood felt like furniture. We varnished the exterior with multiple coats and oiled the interior and the top.
